Technical Report on the
Simon Mine (Ag-Pb-Zn-Cu) Property
Mineral County, Nevada

International Millennium Mining Corp.

May 9th, 2006
Seymour M. Sears, P.Geo.

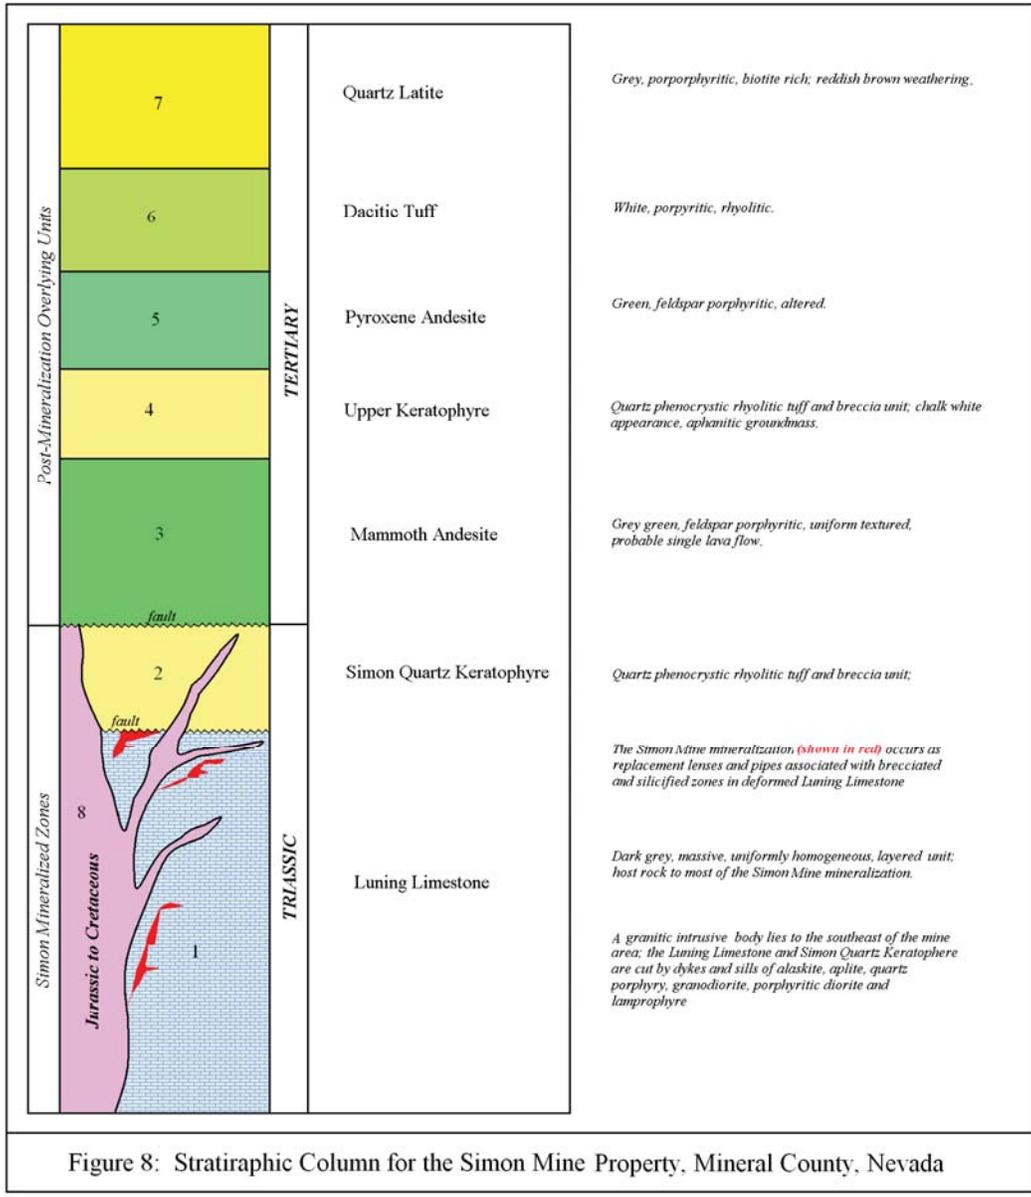
Figure 8: Stratigraphic Column for the Simon Mine Property, Mineral County, Nevada

The Simon Mine property is underlain by a large body of Triassic aged limestone that has been intruded by a system of felsic dykes and overlain by Tertiary volcanics (Figures 6 and 7). The felsic dykes are thought to be genetically related to a granodioritic pluton that outcrops approximately 700 metres southeast of the Mine. Figure 8 is an approximate representation of the stratigraphic column in the Mine area (adapted from stratigraphic units defined by A. Knopf, 1921).

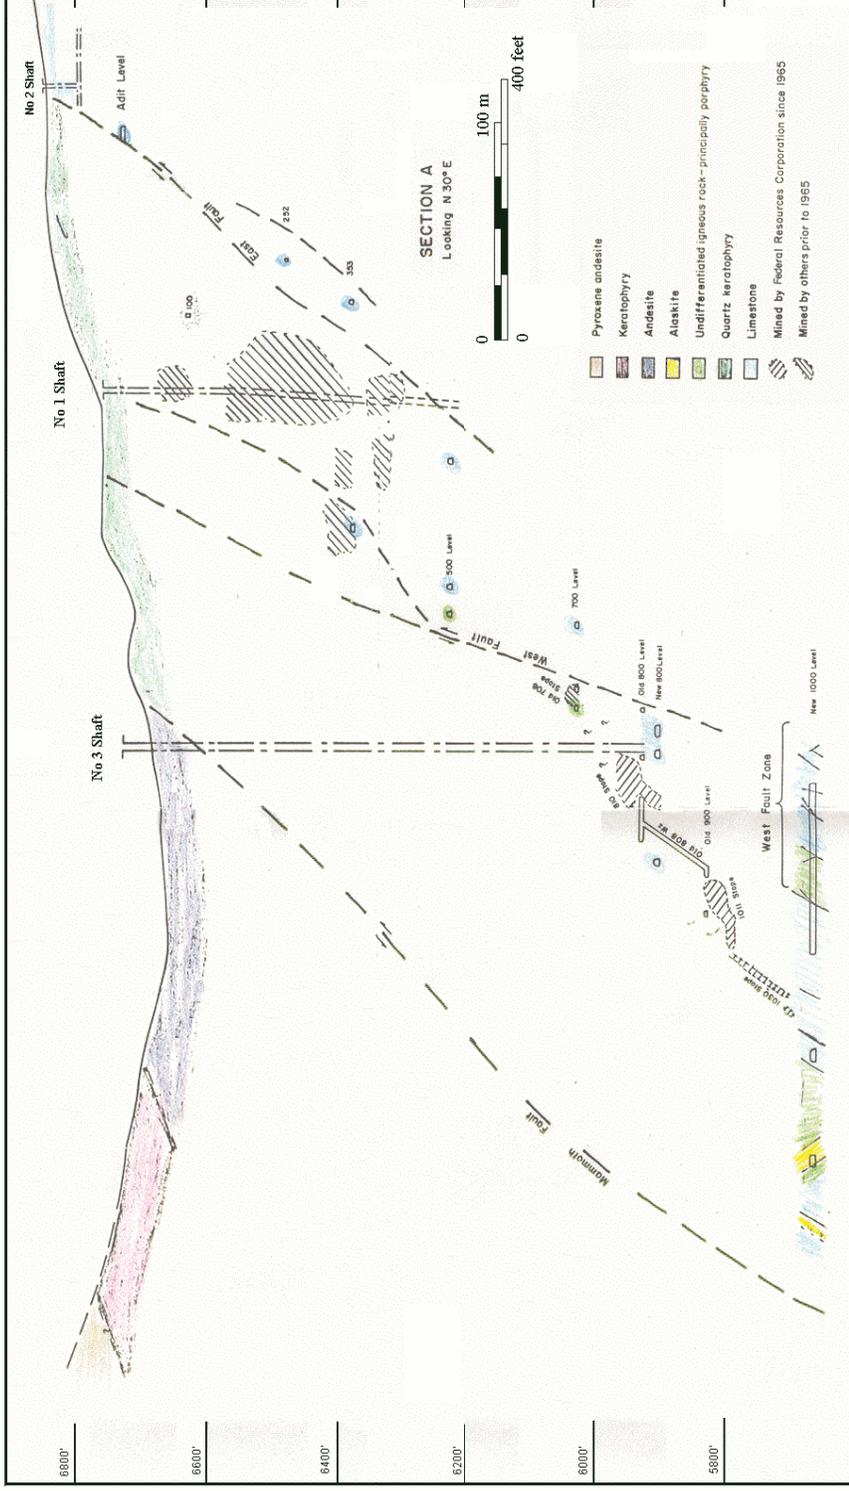
Figure 9: Generalized Longitudinal Section through the Simon Mine, Mineral County, Nevada (adapted from Leonard J. Maki & Associates, 1980)

The Simon Mine deposits consist of pipe-like zones of massive sulphides that have replaced and formed the matrix of brecciated limestone. The known zones at the Mine are relatively small and very irregular, ranging from a few feet to in excess of 80 feet wide and up to 200 feet long. As a general rule the long axis of the individual lenses have an east-west trend, although this is often distorted by local faulting. They pinch and swell in a vertical direction and are also offset by the extensive faulting. These faults cause the zones to be displaced downward in a westward direction, being exposed at surface in the East near the #1 shaft and at a depth of 1000 feet approximately 1400 feet to the west as shown on a schematic longitudinal section (Figure 9).

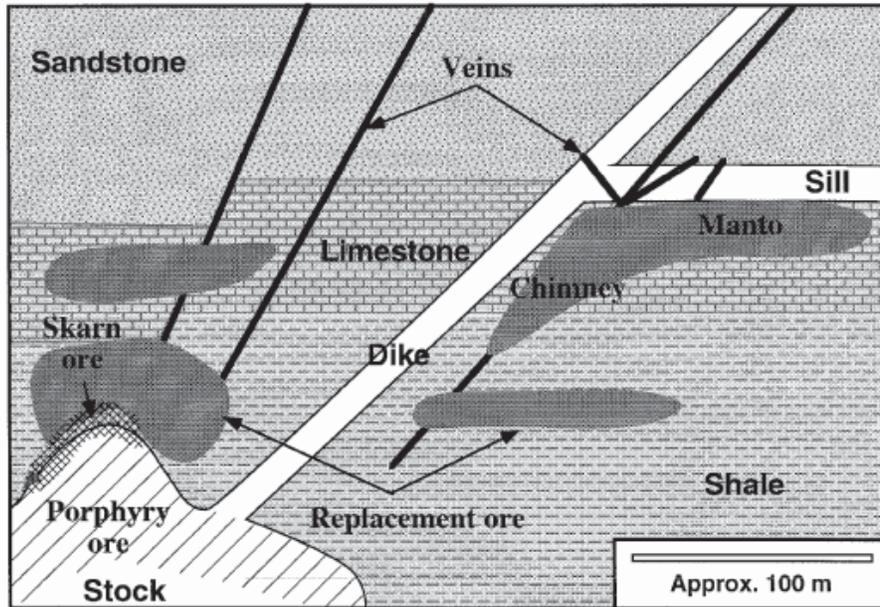
Figure 10: Schematic vertical section through a polymetallic replacement deposit showing distribution of ore types and rocks (USGS Open File Report 95-831)

gold frequently accompany the mineralization. This type of deposit ranges from a few thousand tonnes to as much as 30-40 million tonnes. Grades range from tens to hundreds of grams/tonne Ag and from 5-20% combined Pb-Zn-Cu. Figure 10 is a schematic representation of the geological setting for a typical polymetallic replacement deposit.

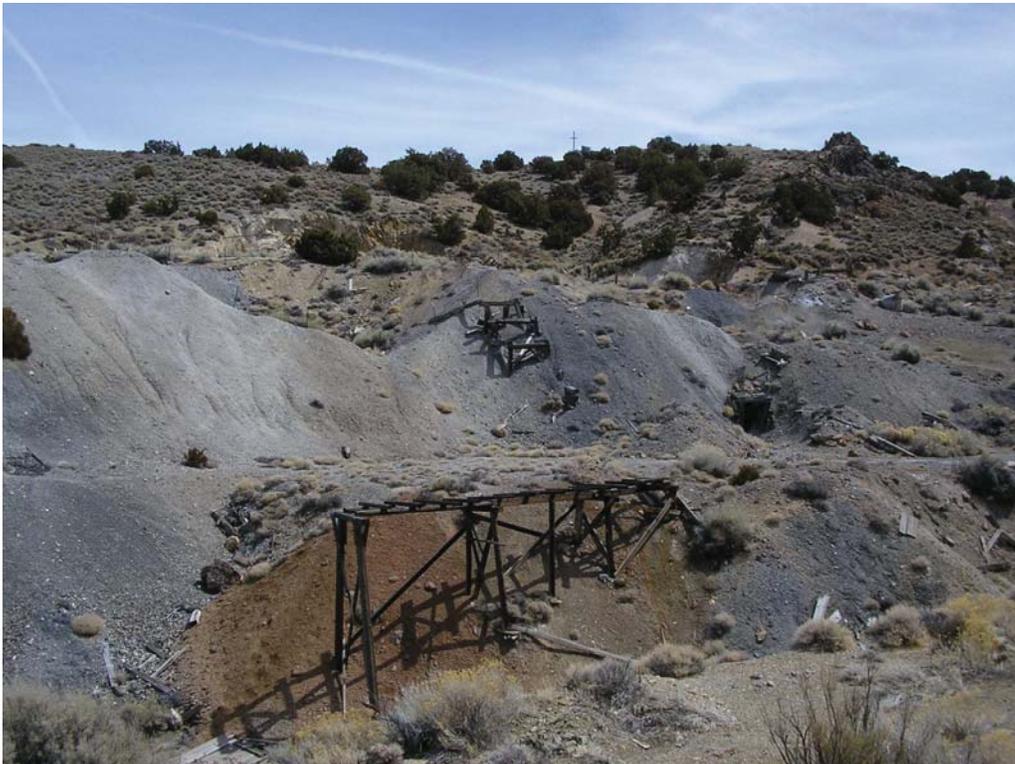
Simon Mine, Nevada – No. 1 Shaft, wastepile & glory hole.

One of these samples was a 0.6 m wide channel sample collected across an altered, gossanous zone at the edge of a rather dangerous surface opening near the # 1 Shaft. This sample contained very little visible sulphides, yet assayed 6.61% Pb, 288 g/t Ag and 3.83 g/t Au. These results suggest that there may be additional exploration potential in the area to the east of the original surface discovery (the #1 shaft area).

The old head-frames that once existed at the 3 shafts are no longer in existence. The # 1 shaft has collapsed, and #3 and #4 are open to the surface (fenced for safety reasons) but not easily accessible. The collars need replacement before any attempt to enter would be possible. The workings are flooded to approximately the 350 foot level so access to

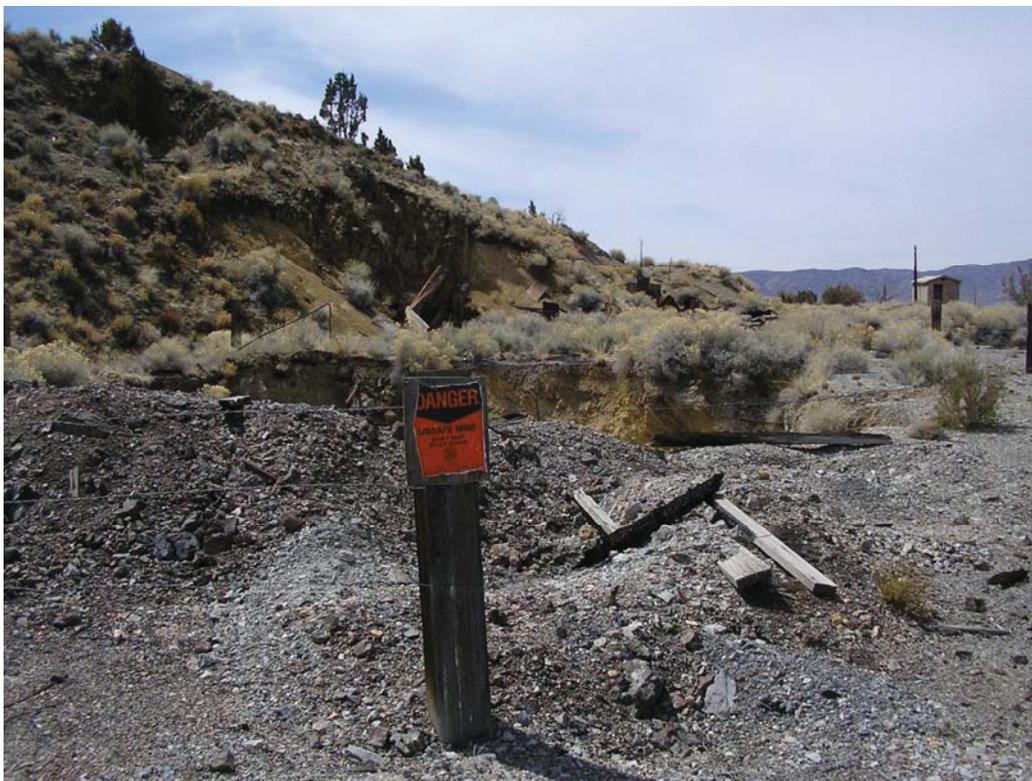
Simon Mine, Nevada – No. 3 Shaft

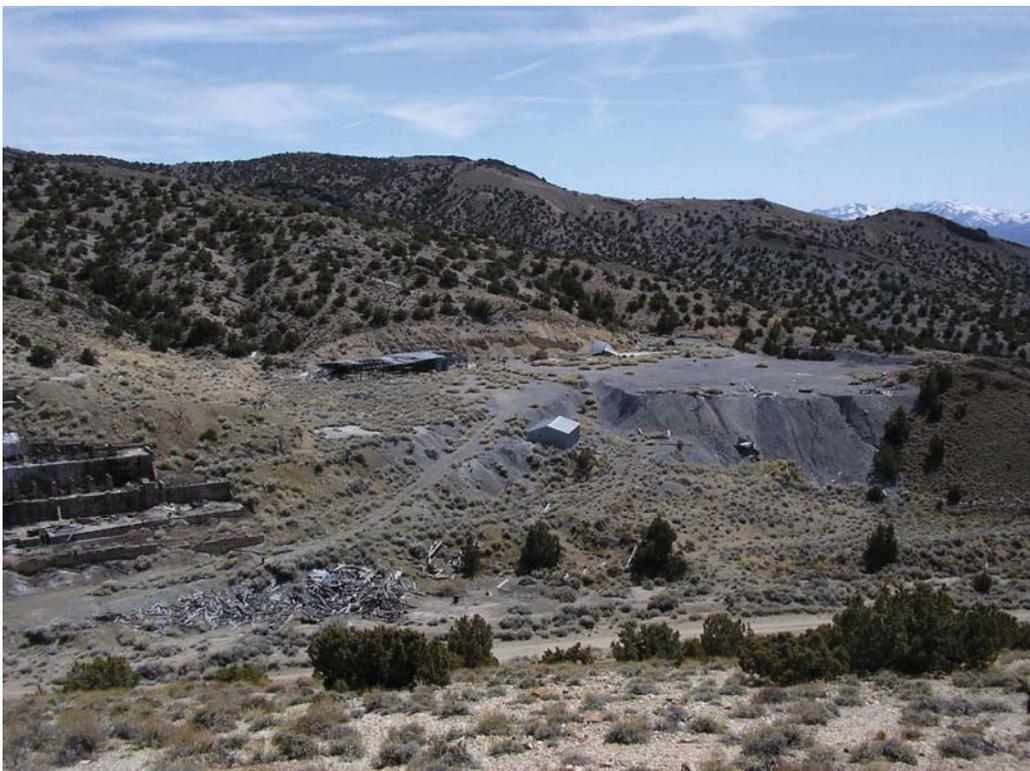
Simon Mine, Nevada – No. 4 Shaft Area

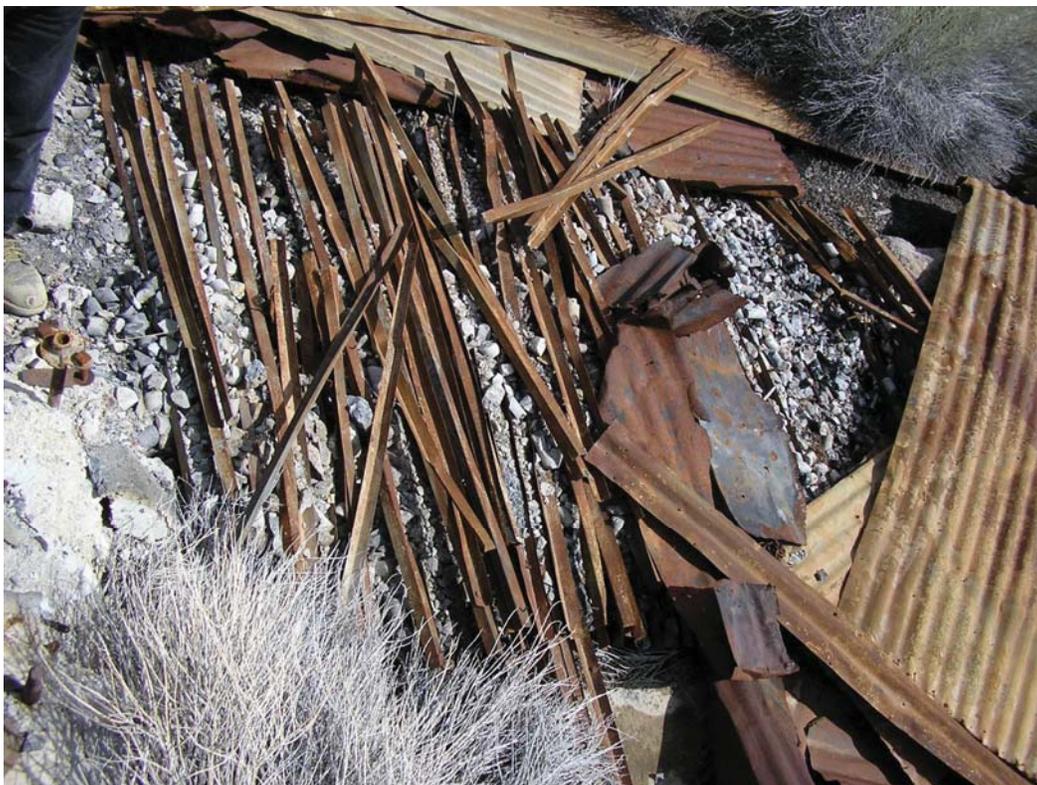
Simon Mine, Nevada – Vandalized core building and racks.

During the period from 1963 to 1968, Federal Resources Corporation held the Simon Property under an option agreement. In addition to underground exploration and development work, the Company completed both surface and underground drilling. At least some of the core from this drill program was stored in buildings near the # 3 Shaft. In the 1980's, vandals burned down the headframe and most of the other wooden structures on site including the core storage buildings basically leaving the core as piles of rubble. Since that time, what remained of the drill core has been pilfered and strewn about beyond all use.

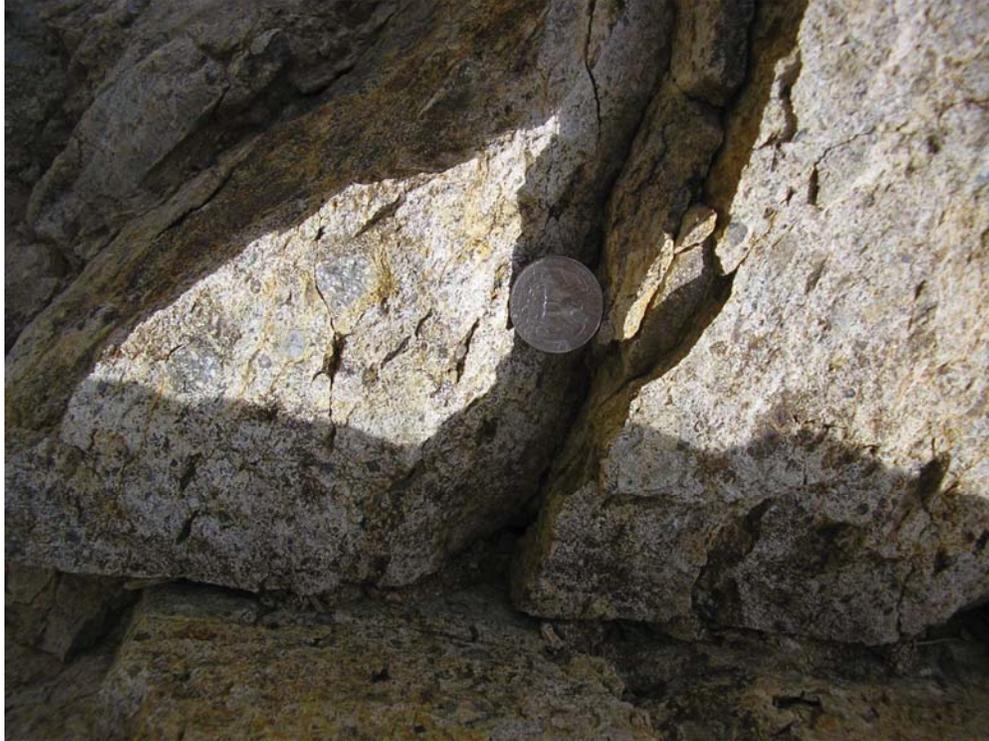
Simon Mine, Nevada – Quartz keratophyre unit.
